Manhole Inspection Summary

Manhole # S19MM_016MH

Location Address: **BEHIND 2137 PULASKI ST**

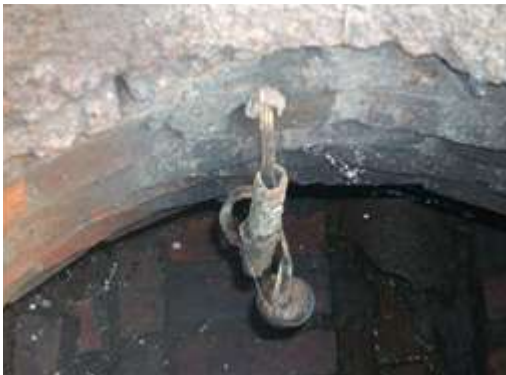
outlet plug coming in

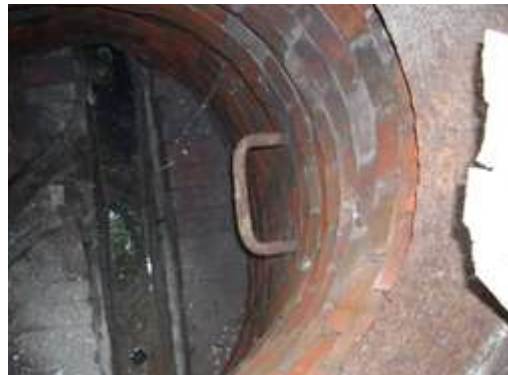
Defect 1

Count: **1** Missing: **0** ☒ **Corroded**

CORRODED STEP

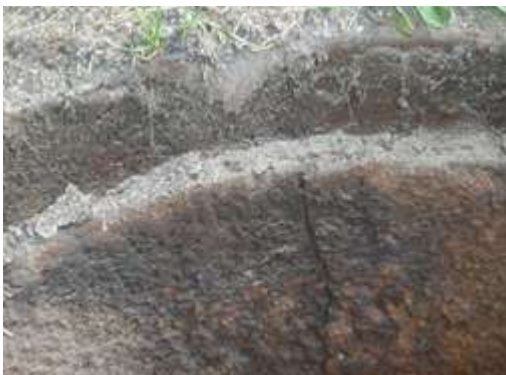
Defect 2

Condition: ☐ Sound ☒ **Cracked** ☐ Leaks

FRAME CRACKED

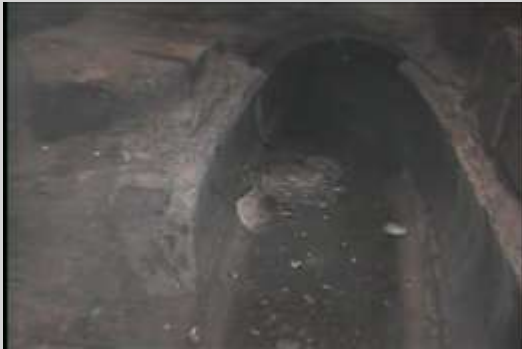
12 O'Clock Outflow

8 in. Circular Gravity Sewer
Pipe Out @ 12 O'Clock

Pipe Height: **8.4** (in.) Rod and Bar (Angled)
Pipe Material: **Clay** ☐ Pipe Lined
Invert Depth: **5.59** (ft.) Flow Characteristics: **Slow**
Deposits: ☐ None ☐ Mud ☐ Sludge ☒ **Debris** ☐ Grease
Silt Depth: **2** (in.) Deposits Extent: **Light**
Infiltration: **None** Pipe Seal Cond: **Sound**

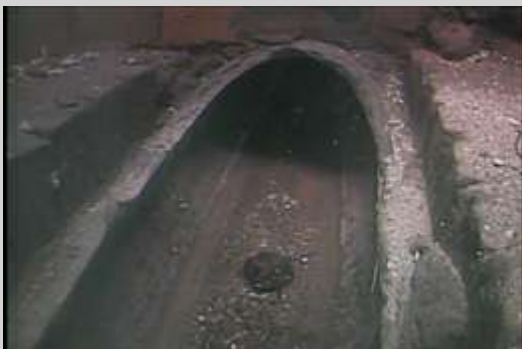
6 O'Clock Inflow

8 in. Circular Gravity Sewer
Pipe In @ 6 O'Clock

Pipe Height: **8.4** (in.) Rod and Bar (Angled)
Pipe Material: **Clay** ☐ Pipe Lined
Invert Depth: **5.50** (ft.) Flow Characteristics: **Slow**
Deposits: ☒ **None** ☐ Mud ☐ Sludge ☐ Debris ☐ Grease
Silt Depth: (in.) Deposits Extent:
Infiltration: **None** Pipe Seal Cond: **Sound**

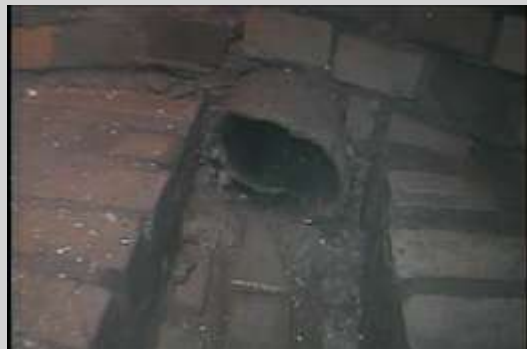
8 O'Clock Inflow

6 in. Circular Gravity Sewer
Pipe In @ 8 O'Clock

Invert Depth: **5.01** (ft.) Flow Characteristics: **None**

Deposits: ☒ None ☐ Mud ☐ Sludge ☐ Debris ☐ Grease
